OU4 Solar Evaporation Ponds Interim Measure/Interim Remedial Action Environmental Assessment Decision Document

U.S. Department of Energy
Rocky Flats Environmental Technology Site
Golden, Colorado

February 1995

Operable Unit 4 Solar Evaporation Pond Interim Measure/Interim Remedial Action - Environmental Assessment Decision Document

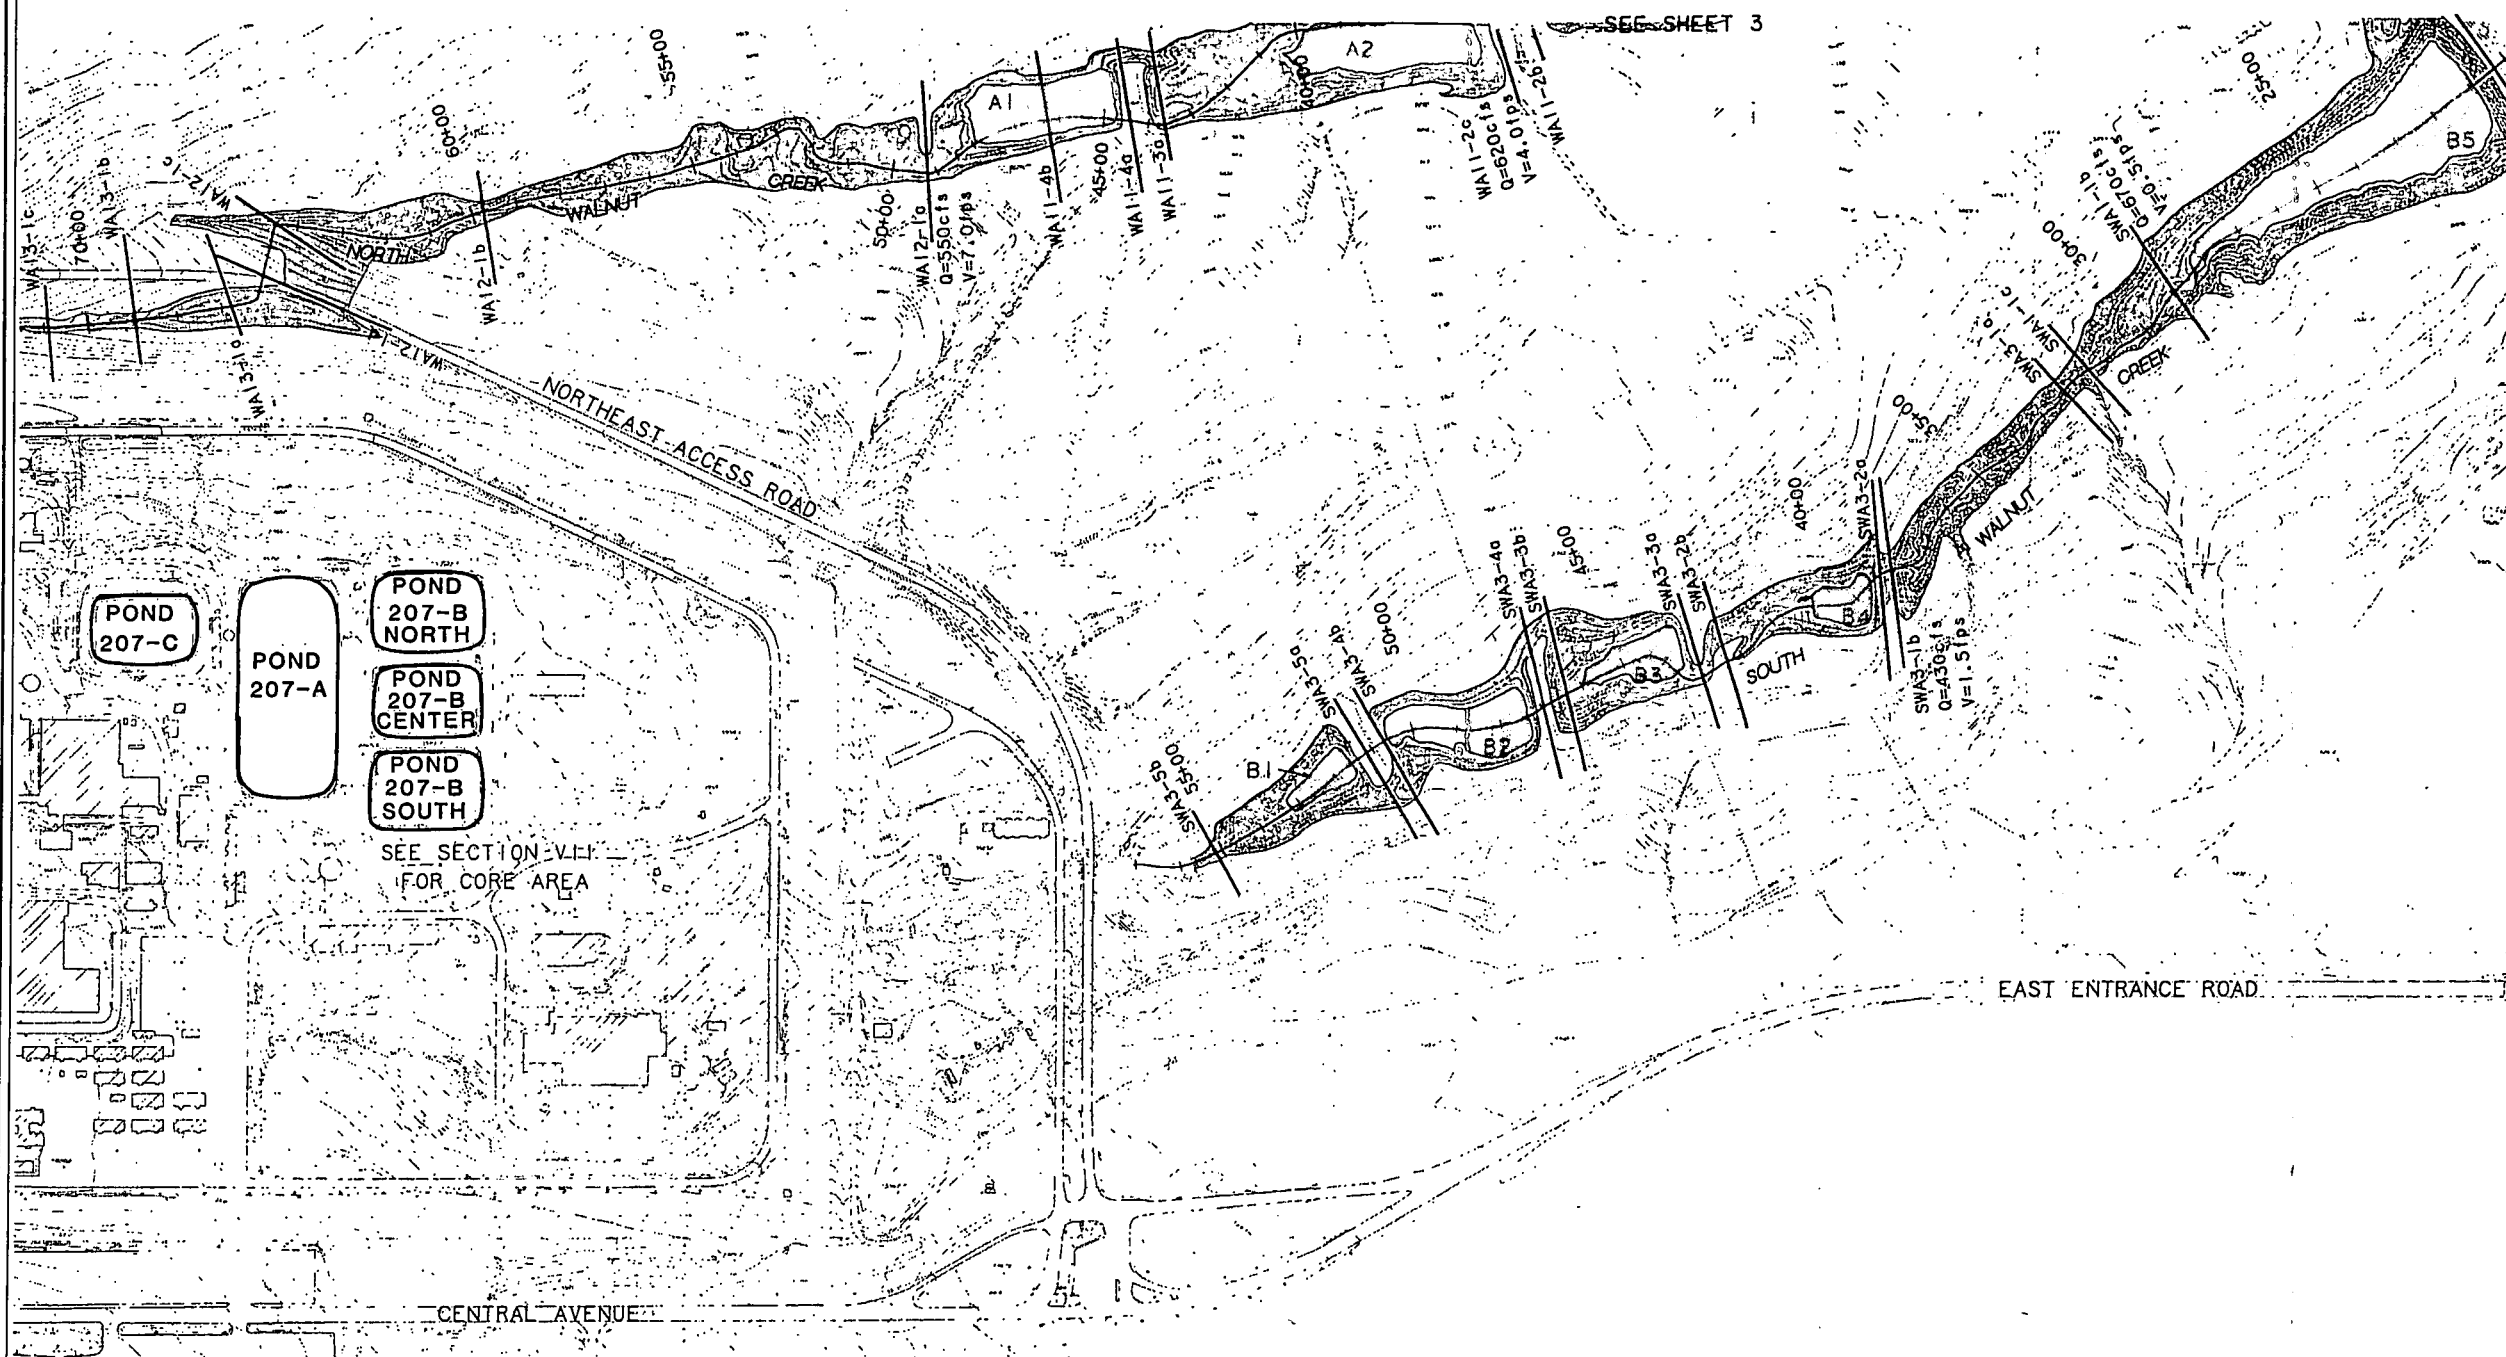
Figure I.4-8

OU4 IM/IRA
North Walnut Creek
100-Year Floodplain
